THE MALDEN SURVEY

A REPORT ON THE CHURCH PLANTS OF
A TYPICAL CITY, SHOWING THE USE
OF THE INTERCHURCH WORLD MOVE-
MENT SCORE CARD AND STANDARDS
FOR RATING CITY CHURCH PLANTS

Compiled Under the Direction of
WALTER SCOTT ATHEARN

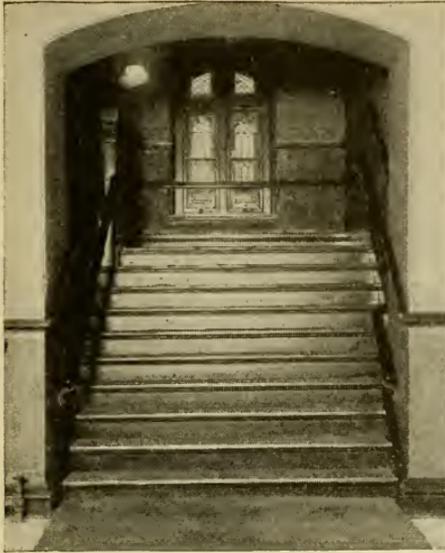
ILLUSTRATION 25. ONE OF TWO MAIN STAIRWAYS FROM THE LARGE AUDITORIUM OF THE CENTRE METHODIST CHURCH

Illustrations 25 and 26, page 65 show two of the three main stairway exits for the large Centre Methodist auditorium. The front stairways are not provided with adequate natural light. These stairways are not well conceived for the passage of large groups from the auditorium and balcony floors. The rear stairway requires an additional turn at the bottom before the exit doors can be reached. This makes a total of four turns which must be made by a group descending from the second floor to the side entrance. The standard that no storerooms be placed under the stairways unless fireproof is violated in the case of these two stairways.

could reach safety. It is unfortunate that this auditorium has been located as it is. The close proximity of other non-fireproof buildings, the non-fireproof nature of the Centre Methodist structure and the wooden construction of its stairways, as shown in illustrations 25 and 26, page 65, make further precautions for safety quite necessary. Other elements adding to the dangers are the store rooms, and other rooms under the stairways and the fact that the balcony with its seating capacity of 350 to 400 may be considered as being on the third floor.

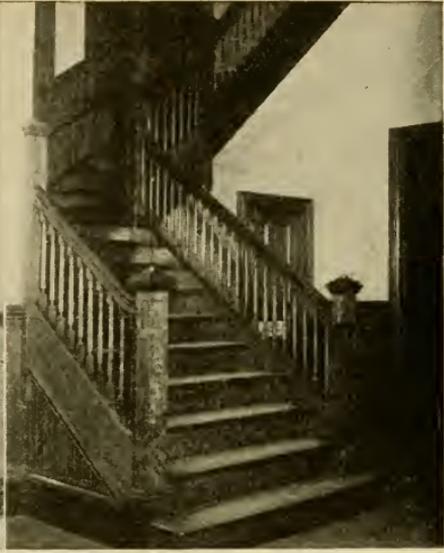
ILLUSTRATION 26. A WOODEN STAIRWAY OF QUESTIONABLE VALUE IN TIME OF DANGER. CENTRE METHODIST CHURCH

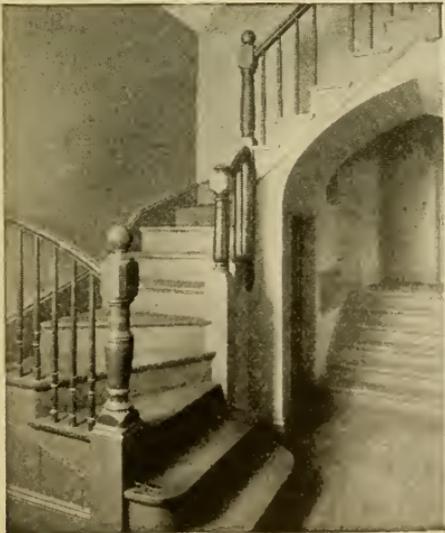
ILLUSTRATION 27. DANGEROUS WINDING STAIRS FOR PRIMARY CHILDREN. ST. PAUL'S EPISCOPAL CHURCH

Illustrations 27 and 28, page 65, of stairways, Maplewood Baptist and St. Paul's plants respectively, are other types of stairways to be found in the seventeen plants. The first stairway is narrow, without handrails and artificial light, doubles back on itself and is located directly over a stairway leading to the littered cellar of illustration 43, page 80. The second stairway is a winder of a very bad type, and lacks handrails and sufficient artificial light. It leads to a classroom where

very young children are taught and is undesirable for this reason.

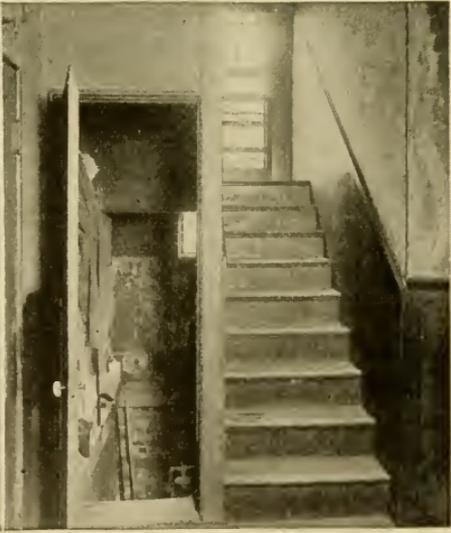
ILLUSTRATION 28. A PROBABLE DEATH TRAP IN CASE OF FIRE. MAPLEWOOD BAPTIST CHURCH

Illustrations 43, page 80, 28, page 65, and 54, page 99, confirm the necessity for this standard. These three pictures lead from a most disreputable basement with every possible fire danger lurking about, to the equally dangerous store room adjoining a class room and located under the partially concealed roof rafters. To be sure, conditions shown in these pictures ought not to be tolerated in any church. Fireproof construction would, on the other hand, ward off the possible results of such disregard for the safety of human beings.

The Maplewood Baptist Church is one of the churches where the rooms are conveniently located both with reference to each other and also to the entrances. The one outstanding defect in this element is the location of the church parlor in a back second floor room reached by the steep narrow stairway shown in illustration 28, page 65.

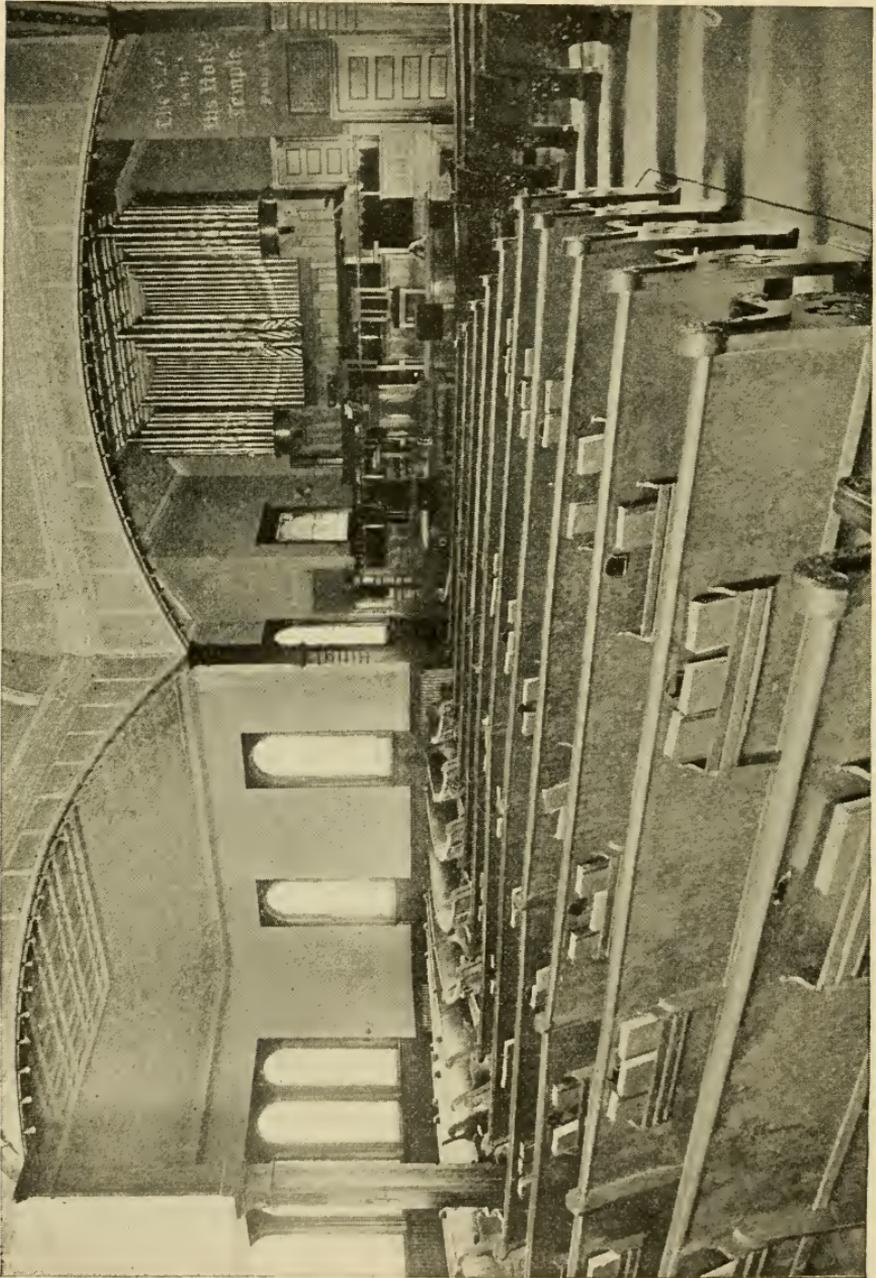
ILLUSTRATION 29 THE SECOND STORY AUDITORIUM, ROBINSON METHODIST CHURCH, THE ONLY EXIT FROM WHICH APPEARS IN ILLUSTRATION 31

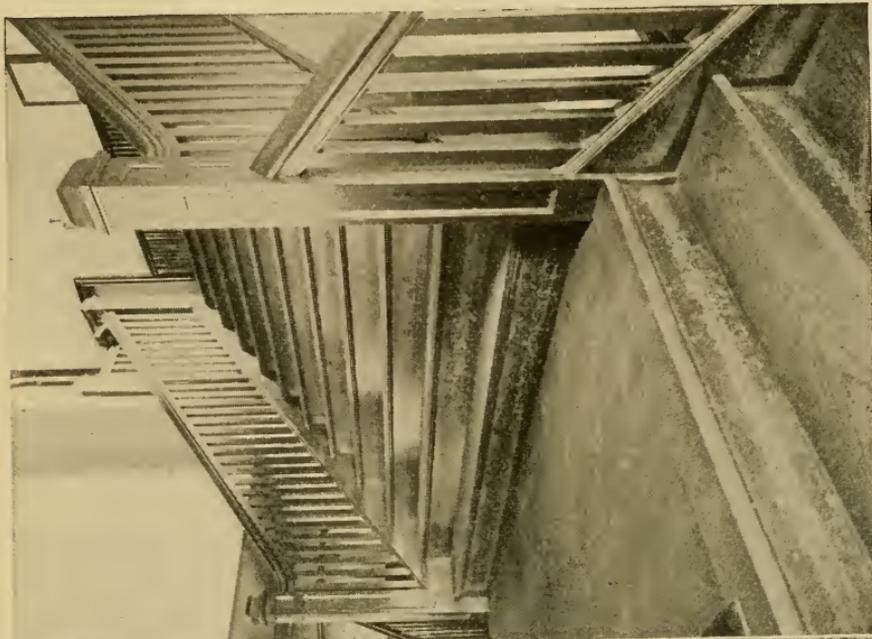
ILLUSTRATION 31. BY ADDING THIS STAIRWAY TO THAT OF ILLUSTRATION 30 ONE MAY VISUALIZE THE ONLY APPROACH TO THE ROBINSON METHODIST AUDITORIUM

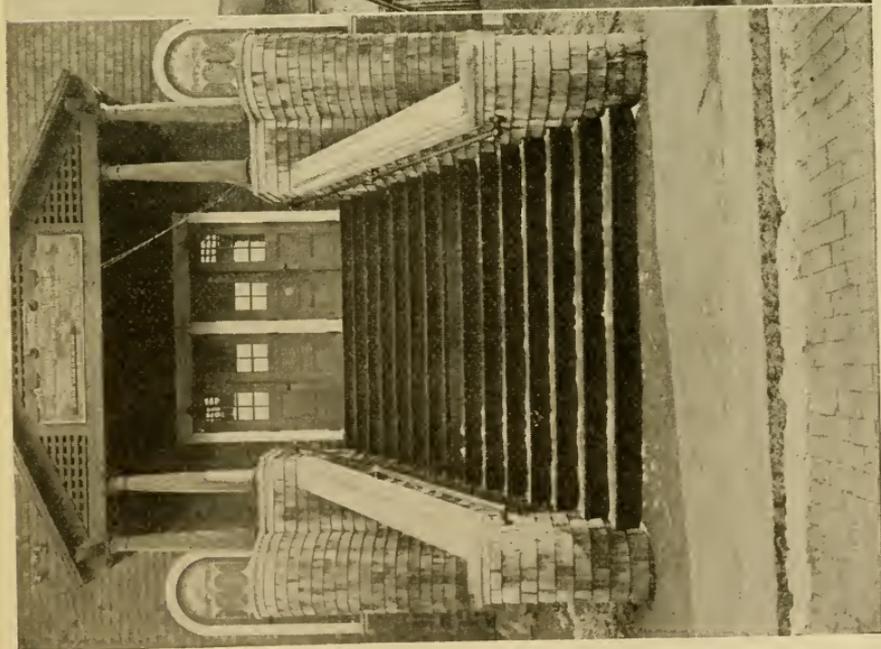
ILLUSTRATION 30. THE FIFTEEN TREAD STEEP FRONT STAIRWAY OF THE ROBINSON METHODIST CHURCH

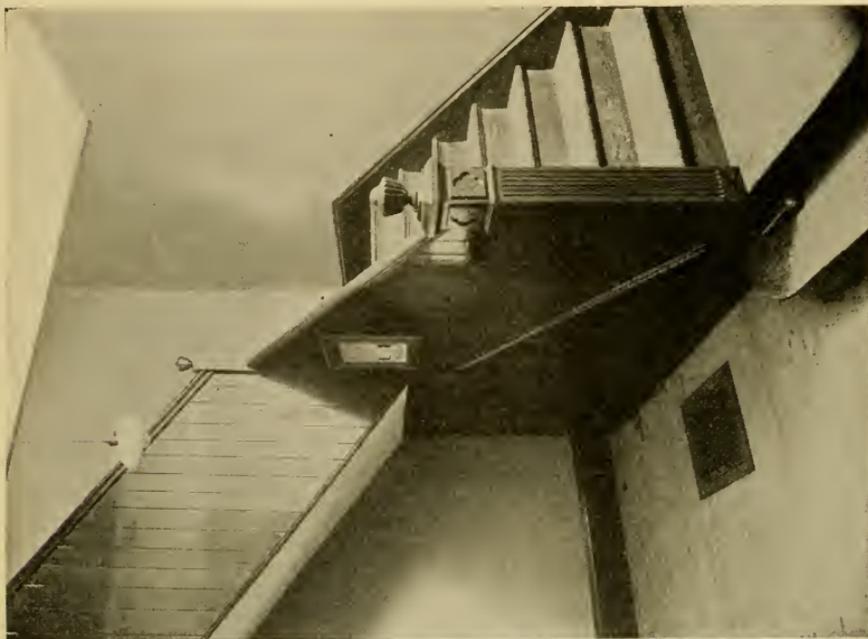
ILLUSTRATION 34. THE UNPROTECTED FRONT STAIRWAY LEADING FROM THE AUDITORIUM SHOWN ON OPPOSITE PAGE

Illustration 34, page 71, reproduces the single main stairway which is used for exit from the auditorium of the Maplewood Methodist Church (see illustration 32, page 70). The secondary stairway to the rear of this auditorium is not superior to the type shown in illustration 36, page 74. This main stairway is of wood, lacks handrails has three turns and is inadequately provided with artificial light.

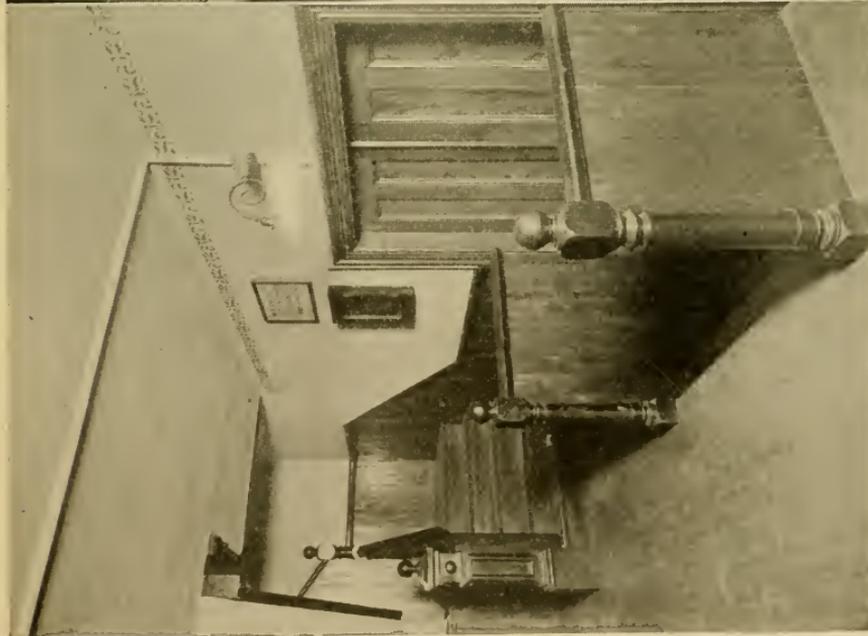
ILLUSTRATION 33. ONE OF TWO VERY POORLY CONCEIVED STAIRWAYS TO THE MAIN AUDITORIUM OF THE LINDEN CONGREGATIONAL CHURCH

Illustration 33, page 71, presents the highly unsatisfactory stairways of the Linden Congregational Church. Each of two stairways to the auditorium on the second floor is so narrow as to be easily congested and has three flights, with two turns. At the foot of the bottom flight, the passageway is partially blocked by the guards to the stairway entrance of the school assembly room on the first floor. Illustration 35, page 72, shows this entrance into the assembly room with the main entrance doors beyond. Since the auxiliary stairway to the rear of this building is entirely inadequate, it is difficult to conceive of a situation which presents greater hazards.

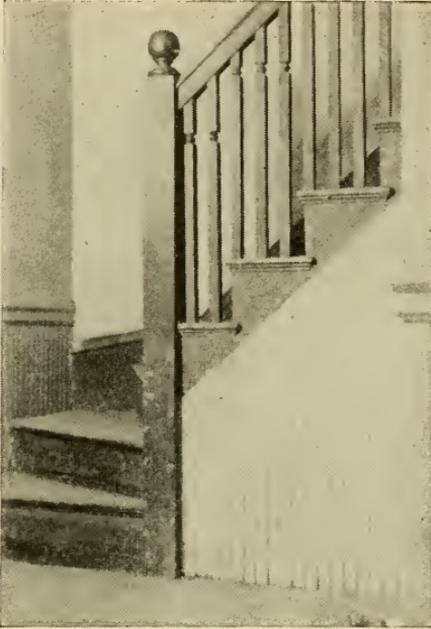
ILLUSTRATION 36. SEE TEXT ON
THIS PAGE

Illustration 36, on this page, shows the only stairway leading from the church auditorium floor to the large assembly room of the basement of the Faulkner Methodist. This stairway is steep, lacks a handrail and has the faulty triangular treads.

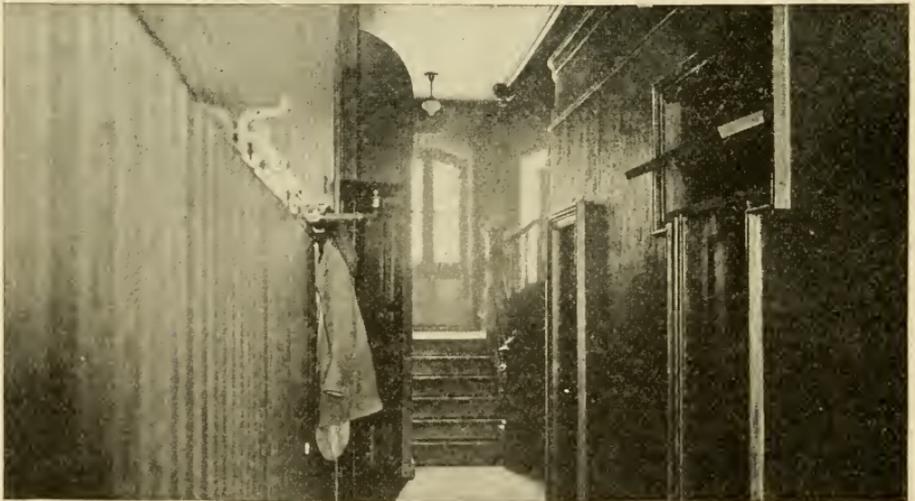
ILLUSTRATION 37. SHOWING THE APPROACH FROM CHURCH AUDITORIUM TO THE SCHOOL ASSEMBLY ROOM OF THE FIRST CONGREGATIONAL CHURCH

The two winding stairways of the First Congregational Church, of which one is shown in illustration 37, page 74, are very defective types of communication between the two main floors of a church structure.

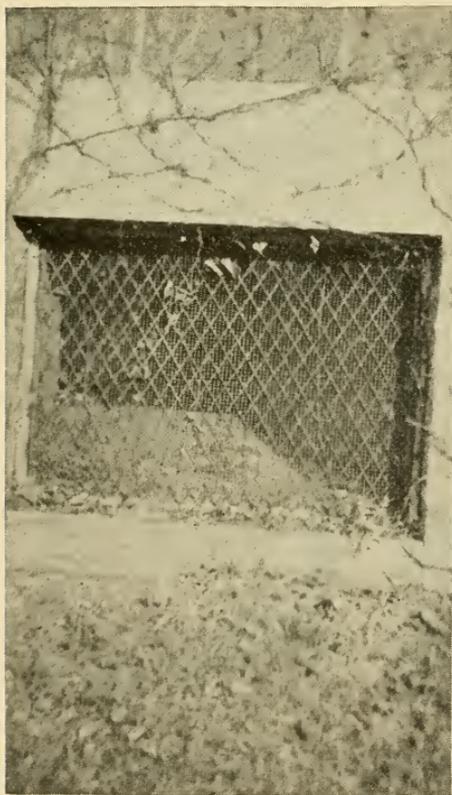
ILLUSTRATION 47. AIR INTAKE OF THE UNIVERSALIST CHURCH, LOCATED AT GROUND LEVEL

Illustrations 47, 48 and 49, pages 90 and 91, point out the prevailing arrangement for securing fresh air in the churches which have made provisions for fresh air supply. Such intakes, even though screened, cannot be as desirable as those located sufficiently high above ground level, and cannot prevent the entry of small dirt particles or dust and filth blown directly from sidewalk or alley. Air drawn from ground levels should be filtered or washed. All heated air should be properly humidified before entering large audience rooms. These provisions are expensive and yet are found possible in large plants. It should be borne in mind that a hot, dry air may be the cause of colds and sore throats for a surprisingly large proportion of an audience.

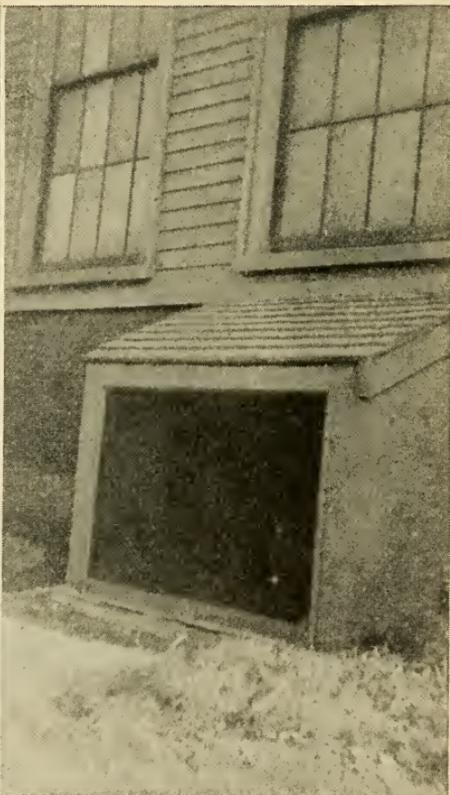
ILLUSTRATION 48. AIR INTAKE OF THE FIRST CONGREGATIONAL CHURCH LOCATED AT GROUND LEVEL

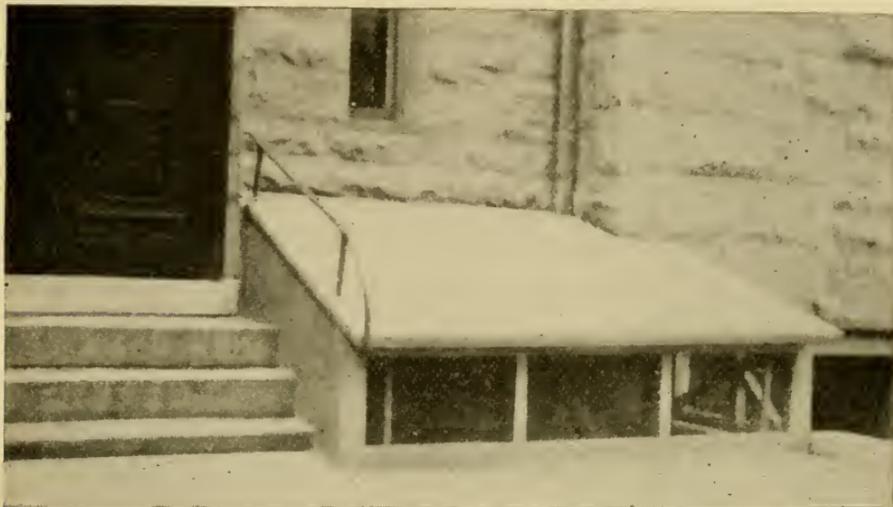
ILLUSTRATION 49. GROUND LEVEL AIR INTAKE OF THE FIRST BAPTIST CHURCH. IT SEEMS UNWISE TO TAKE AIR FROM DUST COVERED WALKS EVEN THOUGH IT IS WASHED BEFORE BEING SENT INTO THE ROOMS ABOVE

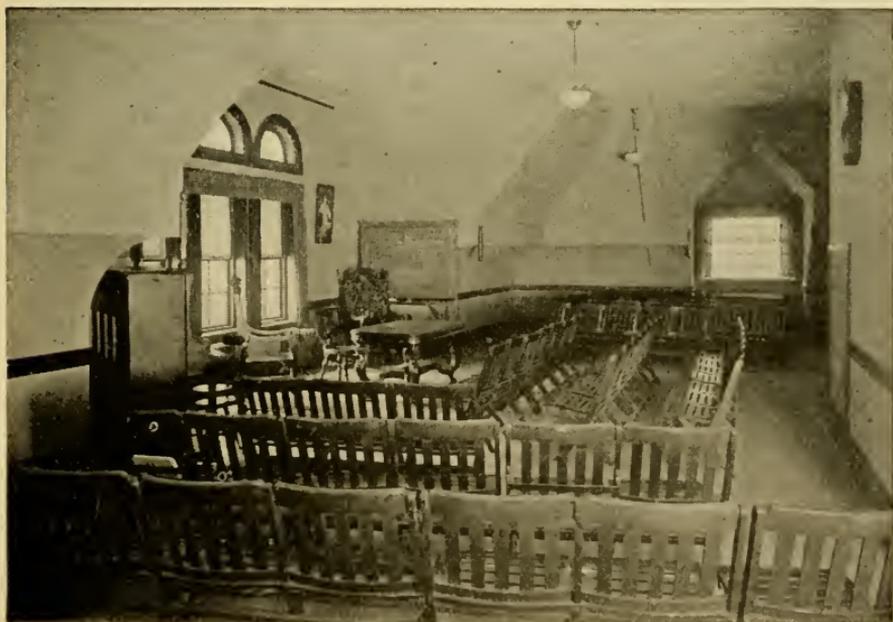
ILLUSTRATION 52. A CLASS ROOM IN THE FIRST BAPTIST CHURCH, THE PLAN OF WHICH WAS MADE SECONDARY TO THE PLANNING OF THE EXTERIOR

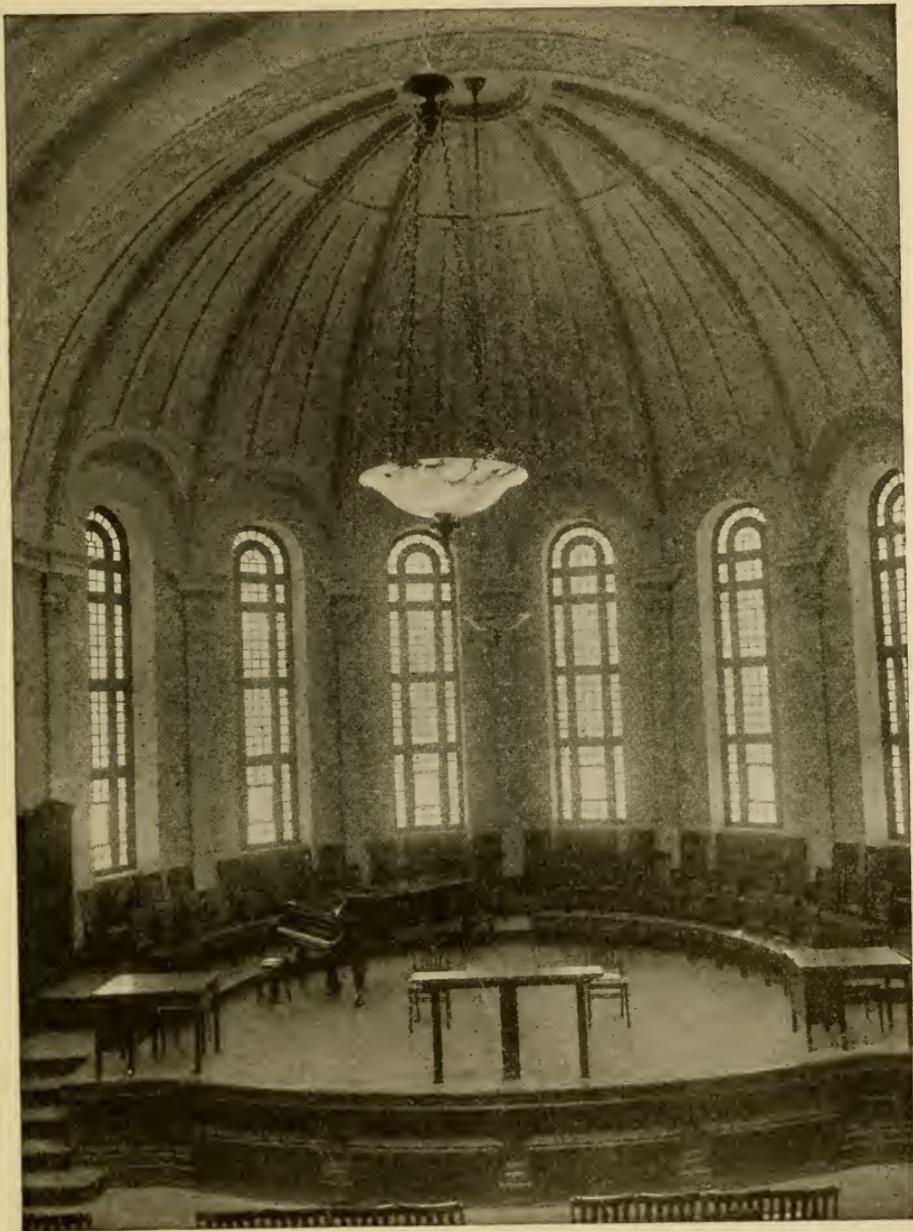
ILLUSTRATION 68. A SUNDAY SCHOOL ASSEMBLY ROOM IN THE FIRST BAPTIST CHURCH. WELL EQUIPPED PLATFORM, AND ATTRACTIVE ROOM, BUT AN ANNOYING SERIES OF CROSS LIGHTS FOR AUDIENCE TO FACE

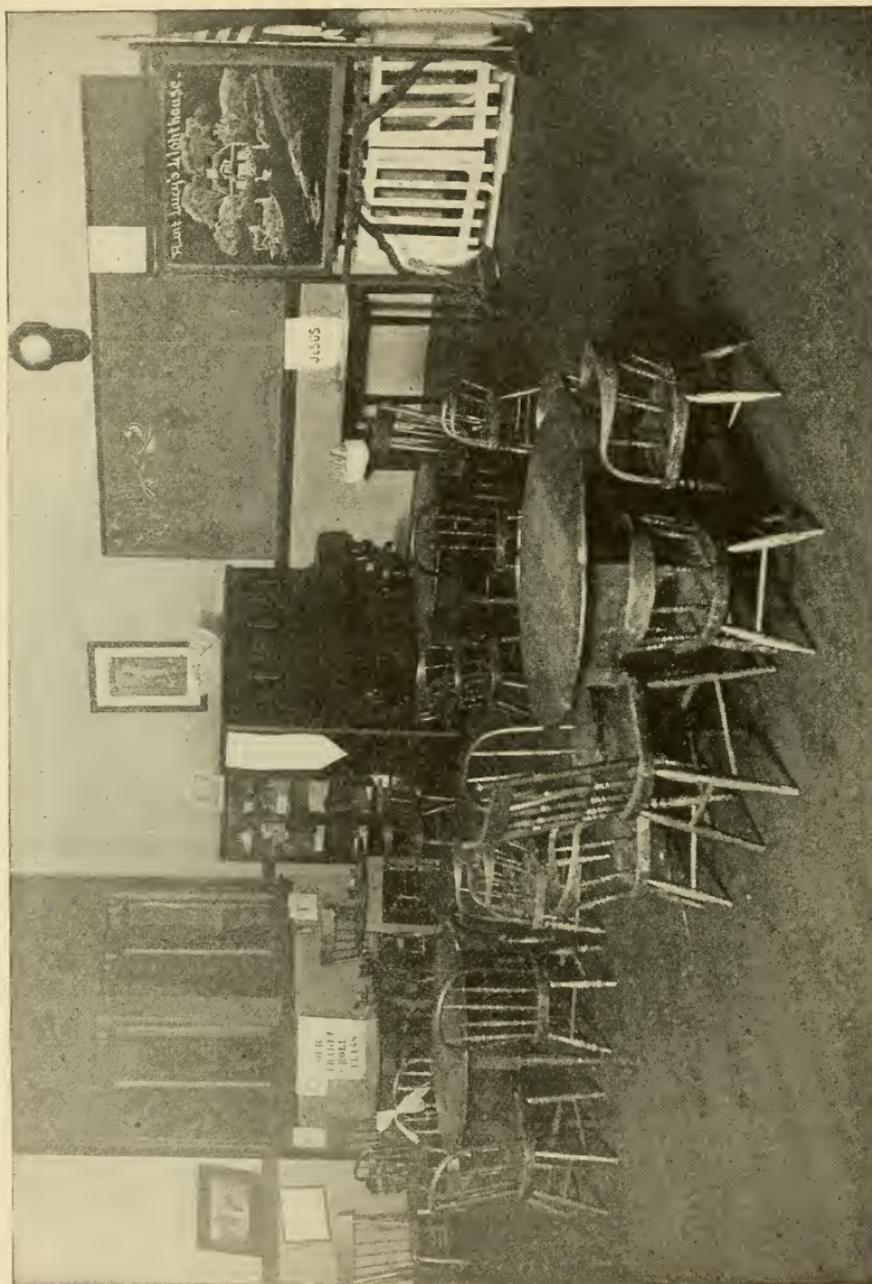
ILLUSTRATION 70. BEGINNERS' CLASS ROOM, CENTRE METHODIST CHURCH. A WELL EQUIPPED CLASS ROOM WITH MANY EVIDENCES OF GOOD TEACHING AND MODERN METHODS. IT IS UNFORTUNATE THAT THIS CLASS ROOM IS LOCATED ON THE SECOND FLOOR

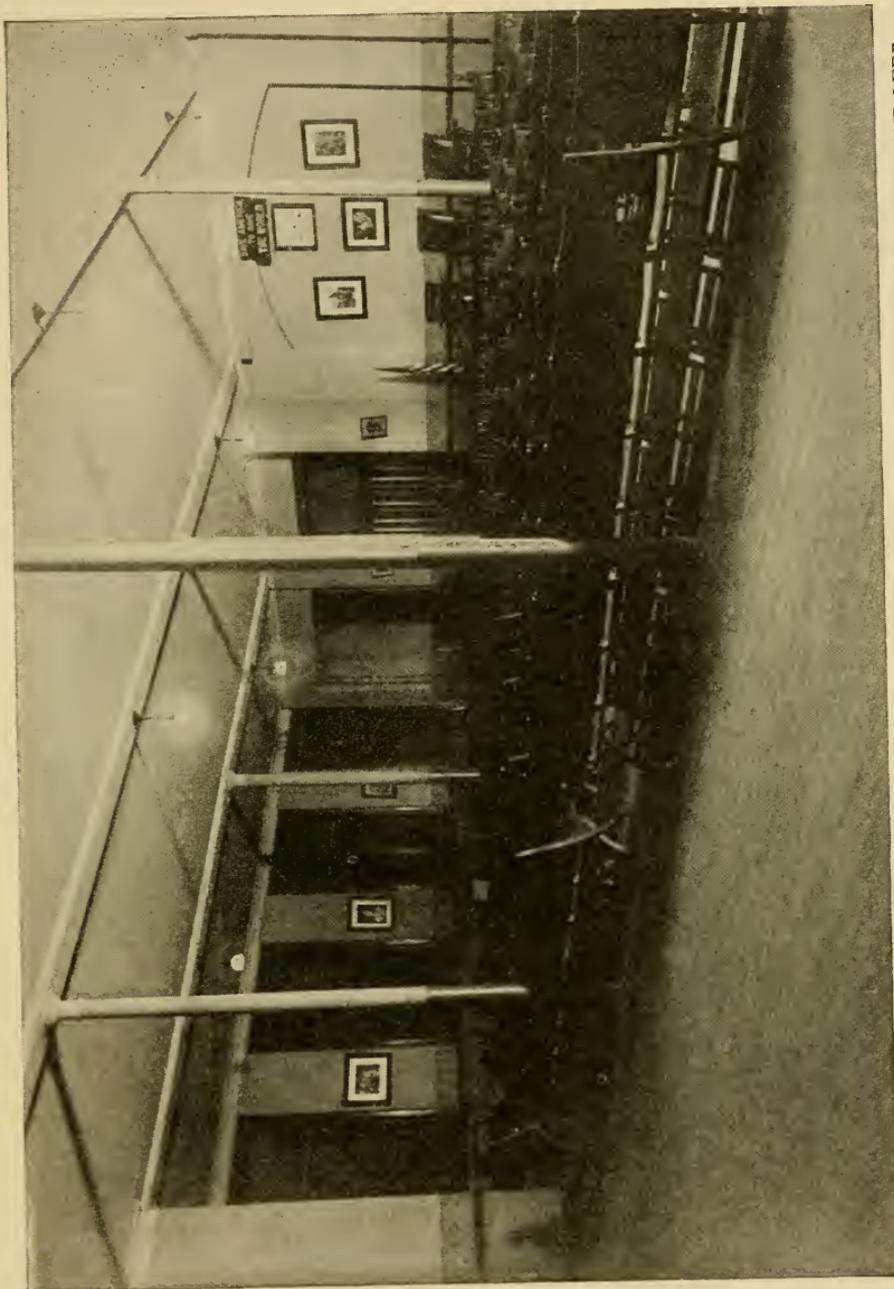
ILLUSTRATION 72. SUNDAY SCHOOL ASSEMBLY ROOM CENTRE METHODIST CHURCH. AT THE RIGHT AND LEFT OF THIS ROOM CLASSES ARE ASSEMBLED ON CHAIRS ABOUT TABLES WITH LITTLE OTHER EQUIPMENT.

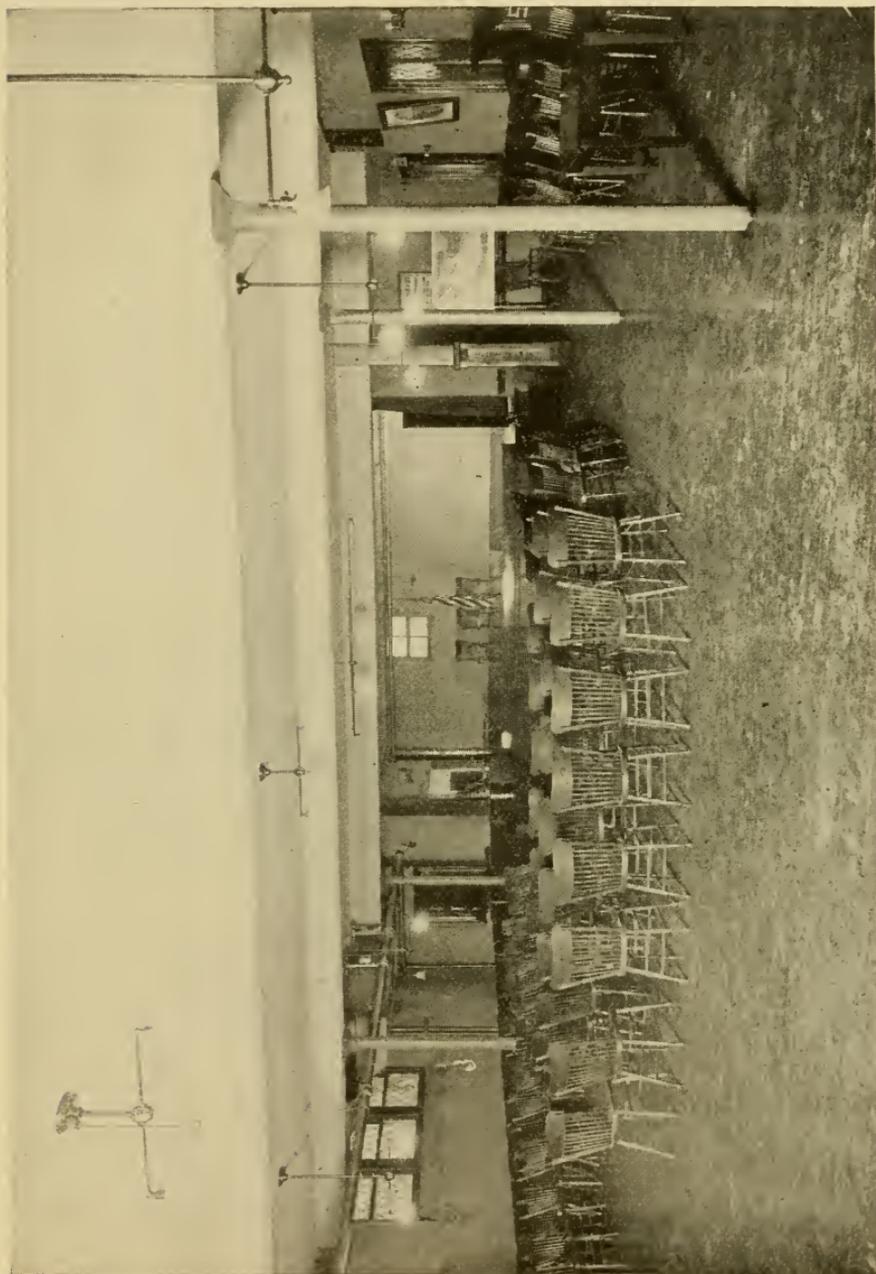
ILLUSTRATION 73. COMMUNITY ROOM OF FIRST PARISH IN MALDEN, UNIVERSALIST CHURCH. A BASEMENT ROOM WITH INSUFFICIENT NATURAL LIGHT. HAS PLATFORM STAGE WHICH CAN BE USED FOR SCHOOL AND COMMUNITY ENTERTAINMENTS

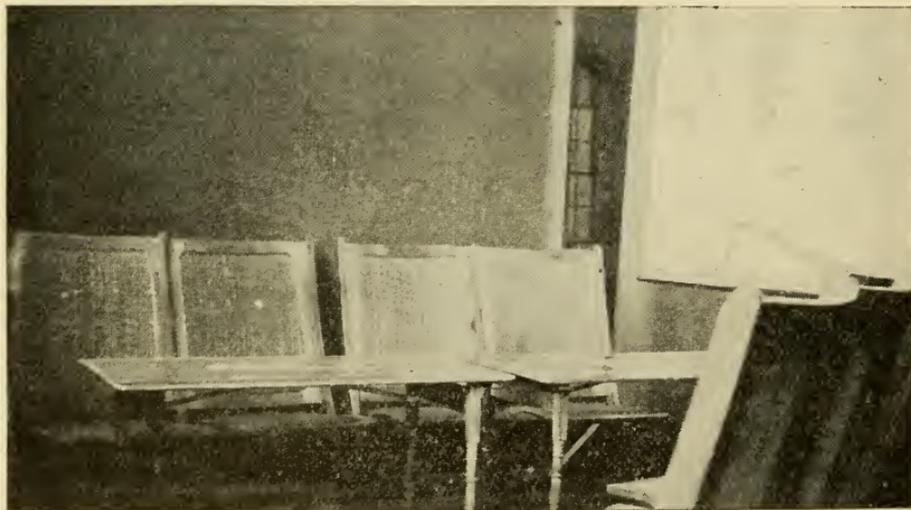
ILLUSTRATION 74. ONE OF SEPARATE CLASS ROOMS MADE BY SCREENS AT THE SIDES OF THE SUNDAY SCHOOL ASSEMBLY OF THE FIRST CONGREGATIONAL CHURCH

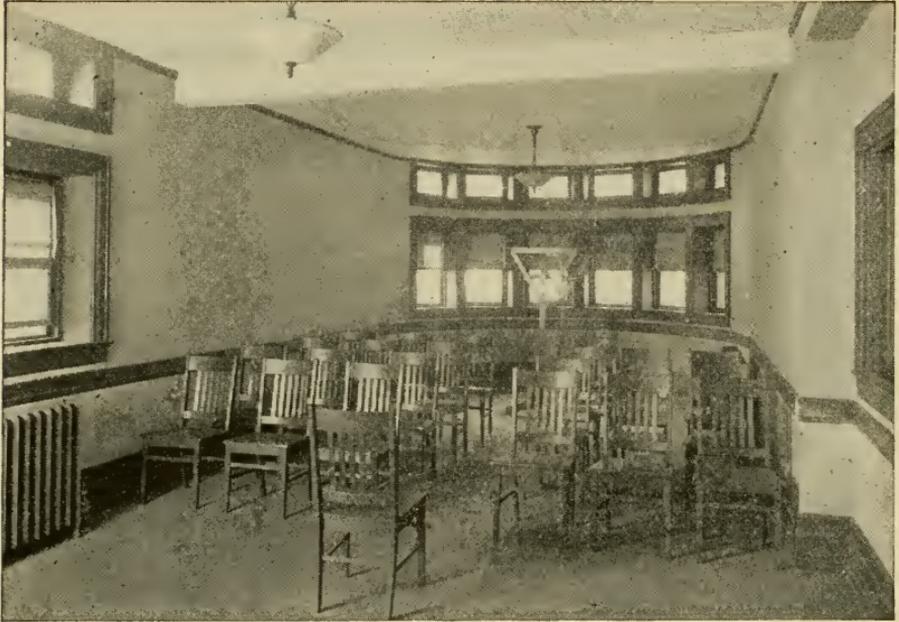
ILLUSTRATION 76. CLASS ROOM OF THE FIRST BAPTIST CHURCH,
EQUIPPED ONLY WITH CHAIRS AND COAT RACKS

A standard class room has doors swinging either outward or having a two-way swing. Even in the most modern plants in Malden this highly desirable standard is not followed. Class rooms should have built-in closets or cases for the storage of books and supplies and where a class room has no built-in closet, a neat cabinet for books, supplies and class exhibits would seem to be indispensable; even in the class rooms like those of illustrations 76 and 70, pages 144 and 132, inadequate provision is made in this matter.

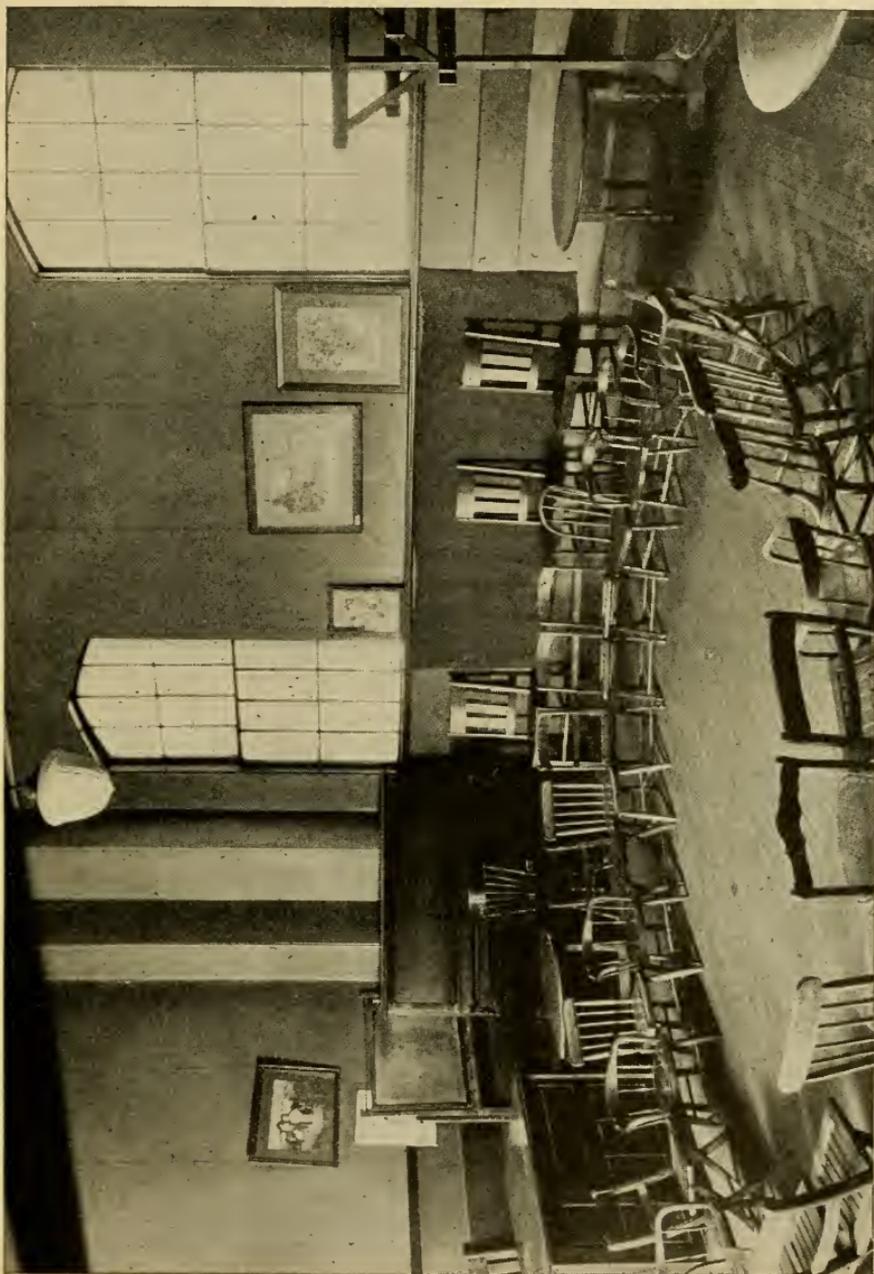
How a well-equipped primary room may be ruined by poor lighting is well shown in the two pictures of the First Congregational Church, illustrations 77 and 21, pages 145 and 57. Viewed by the photographer's flash, the room seems nearly ideal. But through those large windows almost no light comes except at certain times of day; and the second picture shows why. The shadow of the adjoining house falls on the windows like a black curtain, making artificial light a necessity. The church has wisely made this light as soft and pervasive as possible.

ILLUSTRATION 77. PRIMARY CLASS ROOM, FIRST CONGREGATIONAL CHURCH. A WELL ARRANGED AND WELL EQUIPPED ROOM. GOOD ARTIFICIAL LIGHTS OVERCOME THE POOR LIGHT CAUSED BY ADJACENT BUILDINGS. SEE ILLUSTRATION 21, PAGE 57

Blackboards and bulletin boards for the easy mounting of pictures, exhibits and notices were conspicuously rare. In only a few class rooms was there more blackboard space that is furnished by one or two movable blackboards. The use of blackboards for instructional purposes, especially with the younger children, is entirely impossible. A bulletin board or other display surface where pictures or samples of the work of the children may be attractively shown is an easily obtainable and highly desirable asset to modern instruction, and yet it is found in but very few of the religious class rooms of the seventeen churches surveyed. Such a surface made from a strip of burlap is shown in illustration 77, page 145.

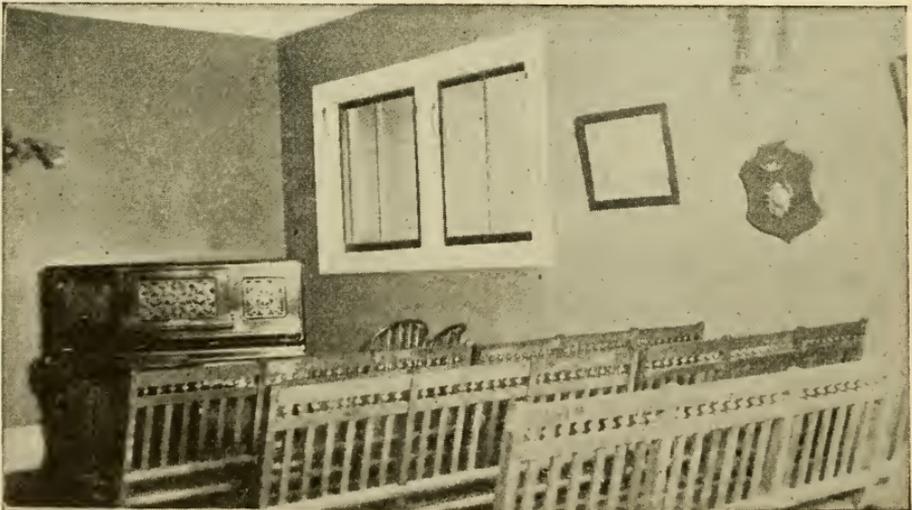
ILLUSTRATION 78. ONE OF THE BEST CLASS ROOMS IN THE RELIGIOUS EDUCATION PART OF ST. PAUL'S EPISCOPAL CHURCH

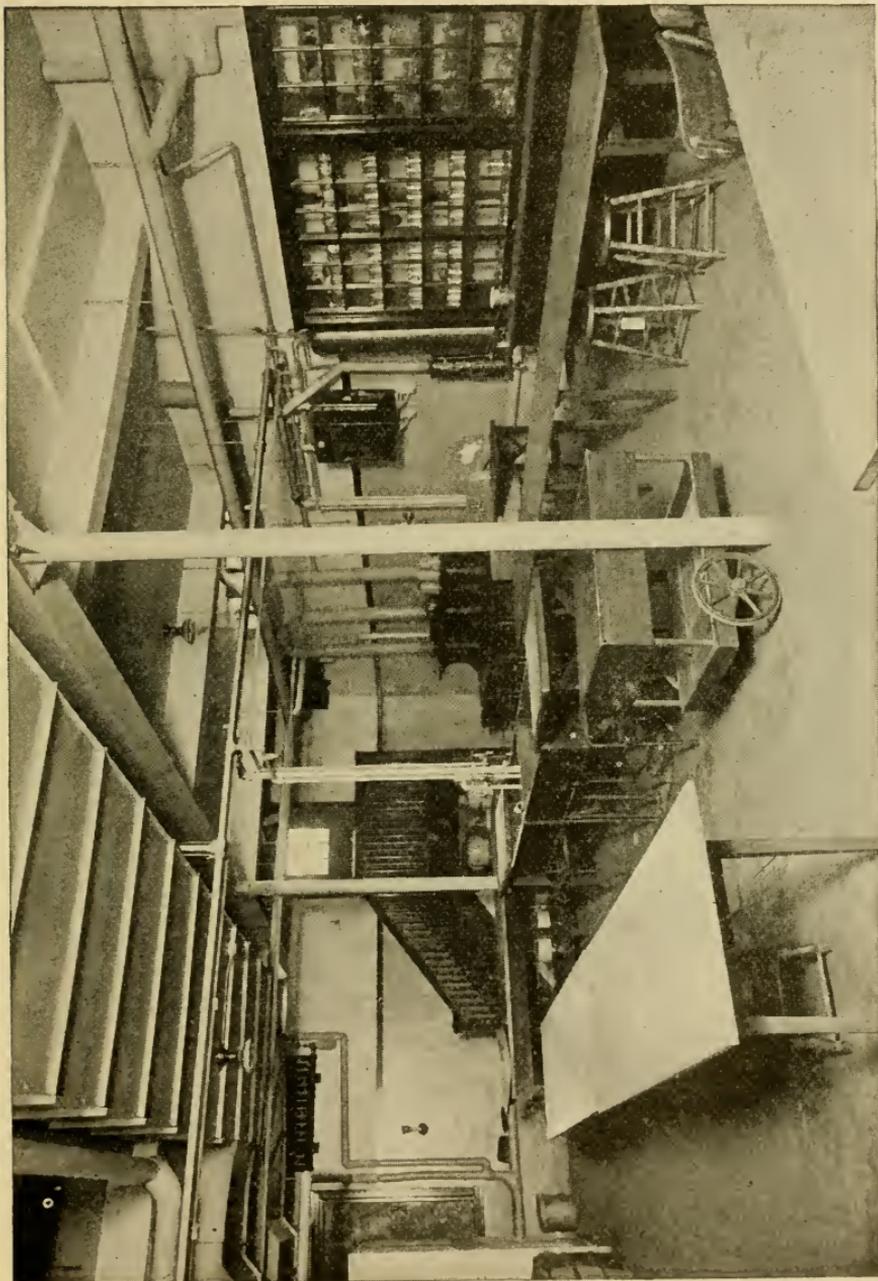
ILLUSTRATION 83. THE WELL APPOINTED KITCHEN OF THE FIRST BAPTIST CHURCH

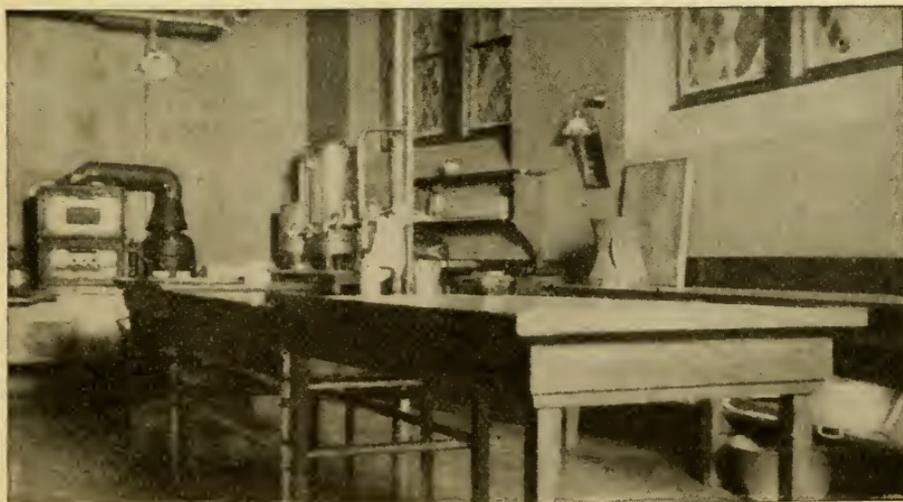
ILLUSTRATION 86. THE FAIRLY WELL EQUIPPED, WELL LIGHTED KITCHEN OF THE FIRST PARISH IN MALDEN, UNIVERSALIST
